# Lewes BPW

## Wastewater PS Condition Assessment Study – Phase 1

### Critical Pump Stations Condition Assessment Report Presentation to the Board

June 29, 2022

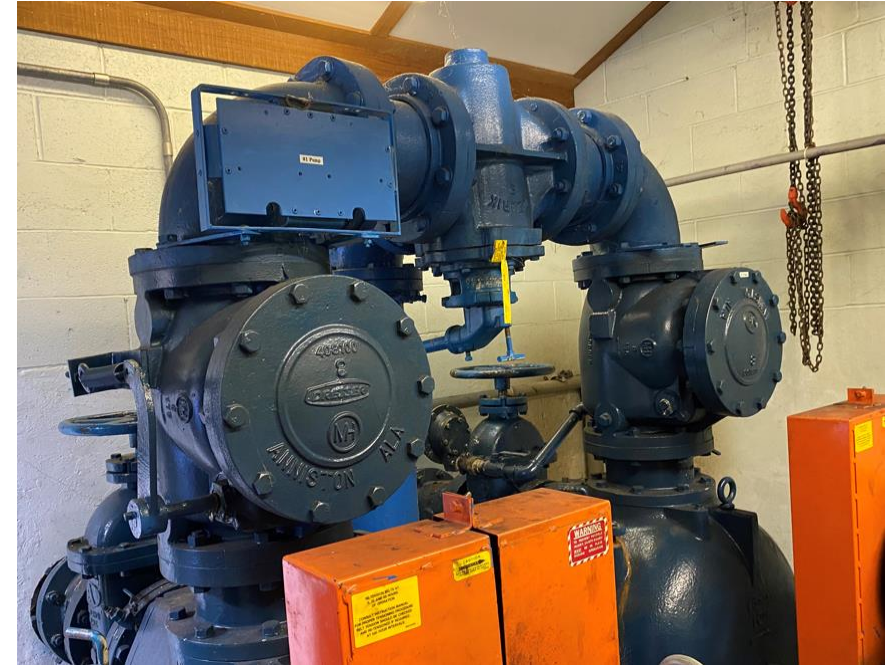
- **Replacement of the existing pumps** (34 years old, replacement is already scheduled); new pumps to have Eradicator Solids Management System pre-installed

- For cost estimating purposes like-for-like replacement of the pumps has been assumed, however the **sizing and selection of the replacement pumps should be deferred until a detailed planning study is completed for the LS-3 sub-catchment**

- Assuming like-for-like replacement proceeds: due to the size of the existing pumps, clogging and blockages due to rags and debris are not typically an issue and **no further capital works are recommended for the wet well or influent piping to mitigate clogging**

- **This work has already been scheduled by BPW**; the existing project budget is not known but this work has been included in the cost estimate
  - Cost estimate includes pumps, motors, check valves (which should be installed horizontally), new NEMA rated control panels and all ancillary equipment

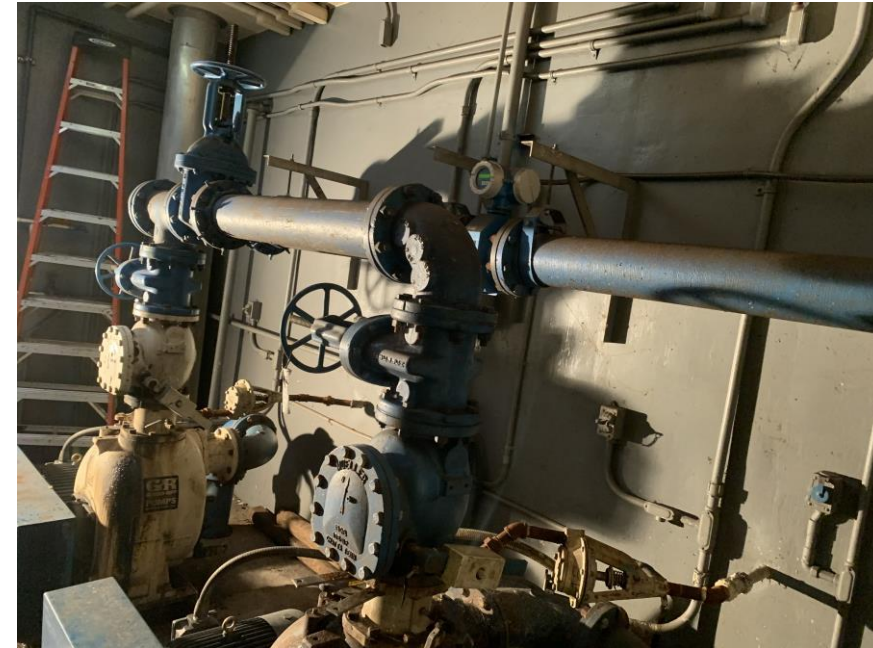
- **Installation of grinders on wet well influent**
  - Clogging at this location occurs in the suction piping as well as at the pump impellers, and therefore the issue should be addressed upstream of the pump intake

- **Replacement of the existing pumps, motors, controls, isolation valves and check valves to enable duty/ standby operation**
  - New pumps should have Eradicator Solids Management Systems pre-installed

- Consideration should be given to reconfiguring the delivery piping so that the check valves are installed horizontally
  - Consideration should be given to dividing the wet well into multiple cells to aid maintenance and cleaning (Ten States)

- **Apply an epoxy lining system** to protect wet well interior concrete surface from raw sewage and H<sub>2</sub>S exposure
- **Install an alarm system** to secure the pump station building and the wet well access covers

- **Replace broken windows and repair damaged roofing**
- **Repair the existing forced ventilation system**

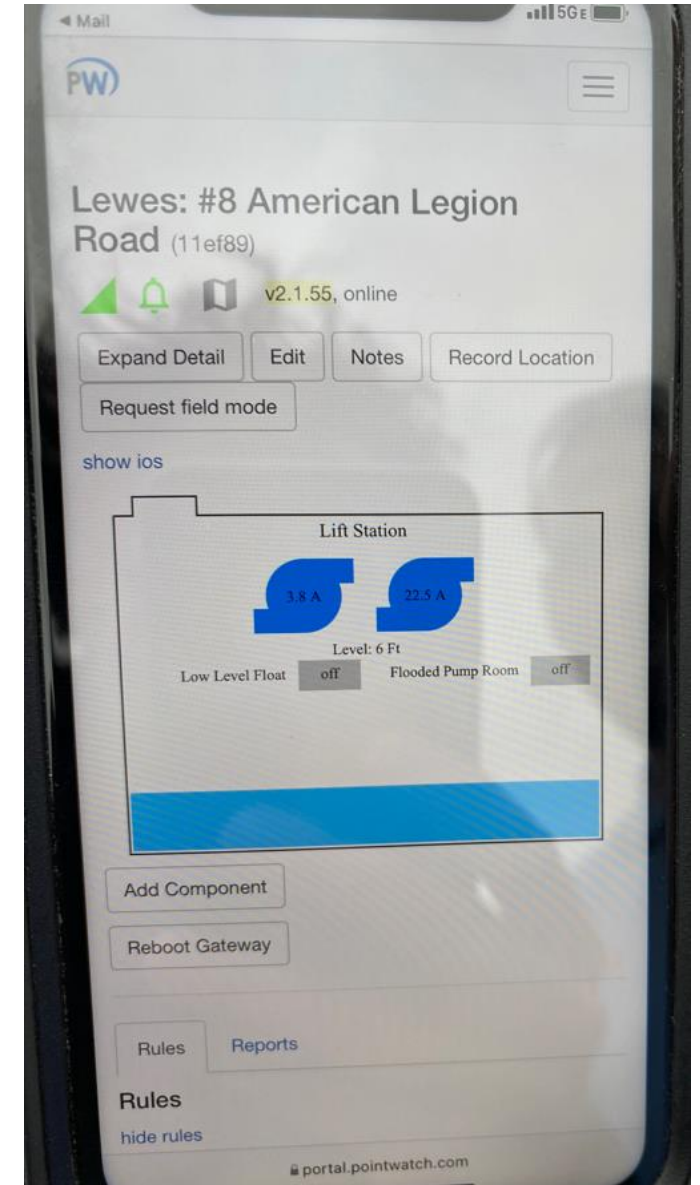
- The PointWatch cellular RTU system is employed at each of the remote pumping stations, which gives mock SCADA capabilities.
- Operators can monitor and receive alarms on cell phones but cannot control remotely.
- PointWatch is also used for pump cycling and is used as a mapping tool to locate pump stations across the network.
- Inframark have noted the following key issues with the PointWatch system:
  - No flow meter data for stations with meters installed
  - There are regular issues with signal coverage at remote sites
  - Several instances have been noted where the alarms were not configured correctly for high level conditions and instead call out for low level conditions
- BPW does not currently have a secondary method of communication for the remote pump stations if there is an issue with PointWatch.
